Manhole Inspection Summary

Manhole # S29GG_040MH

Insp Date: **1/3/07 10:32 AM**

Location Address: **1416 BOLTON ST**

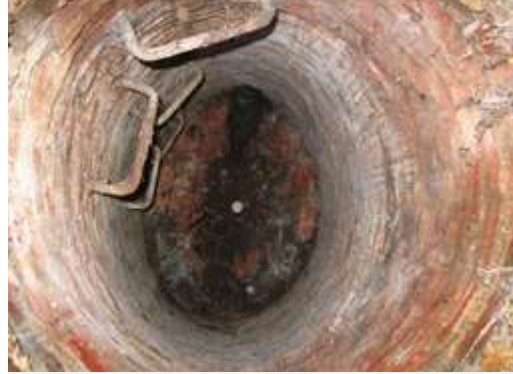
Top View

Corroded steps. Channel debris.

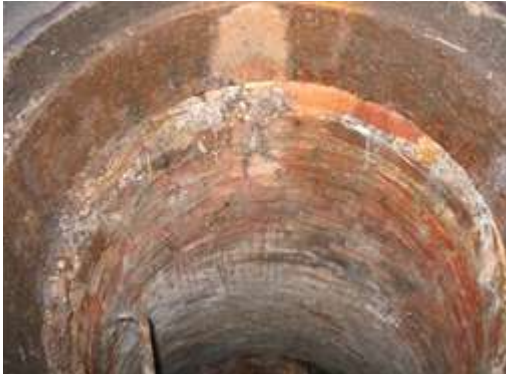
Defect

☒ **Leaks**

Condition: ☐ Sound ☐ Cracked ☐ Root Intrusion ☐ Loose Brick ☒ **Deteriorated**

Infiltration: ☐ None ☒ **Joint** ☐ Cracks ☒ **Mortar** ☐ Roots ☐ Wall

Infiltration: ☐ None ☐ Joint ☐ Cracks ☒ **Mortar** ☐ Roots ☒ **Wall**

Frame leaks. Adjustment deterioration and infiltration. Corbel infiltration.

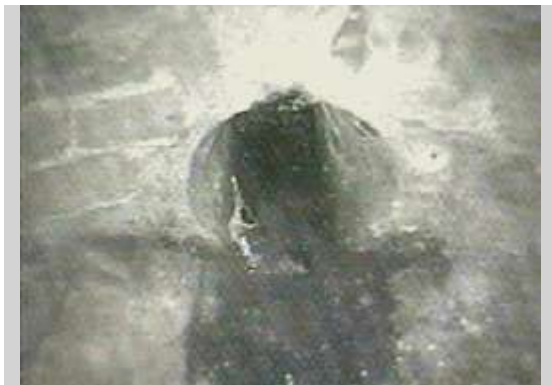
Pipe Out @ 12 O'Clock

8 in. Circular Gravity Sewer

Pipe Material: **Clay**

Invert Depth: **9.45** (ft.) Flow Characteristics: **None**

Infiltration: **None**
